# AFM pictures of the surfaces of glass RPC electrodes damaged by water vapor contamination

T. Kubo, E. Nakano and Y. Teramoto

*Institute for Cosmic Ray Physics, Osaka City University, Osaka 558-8585, Japan*

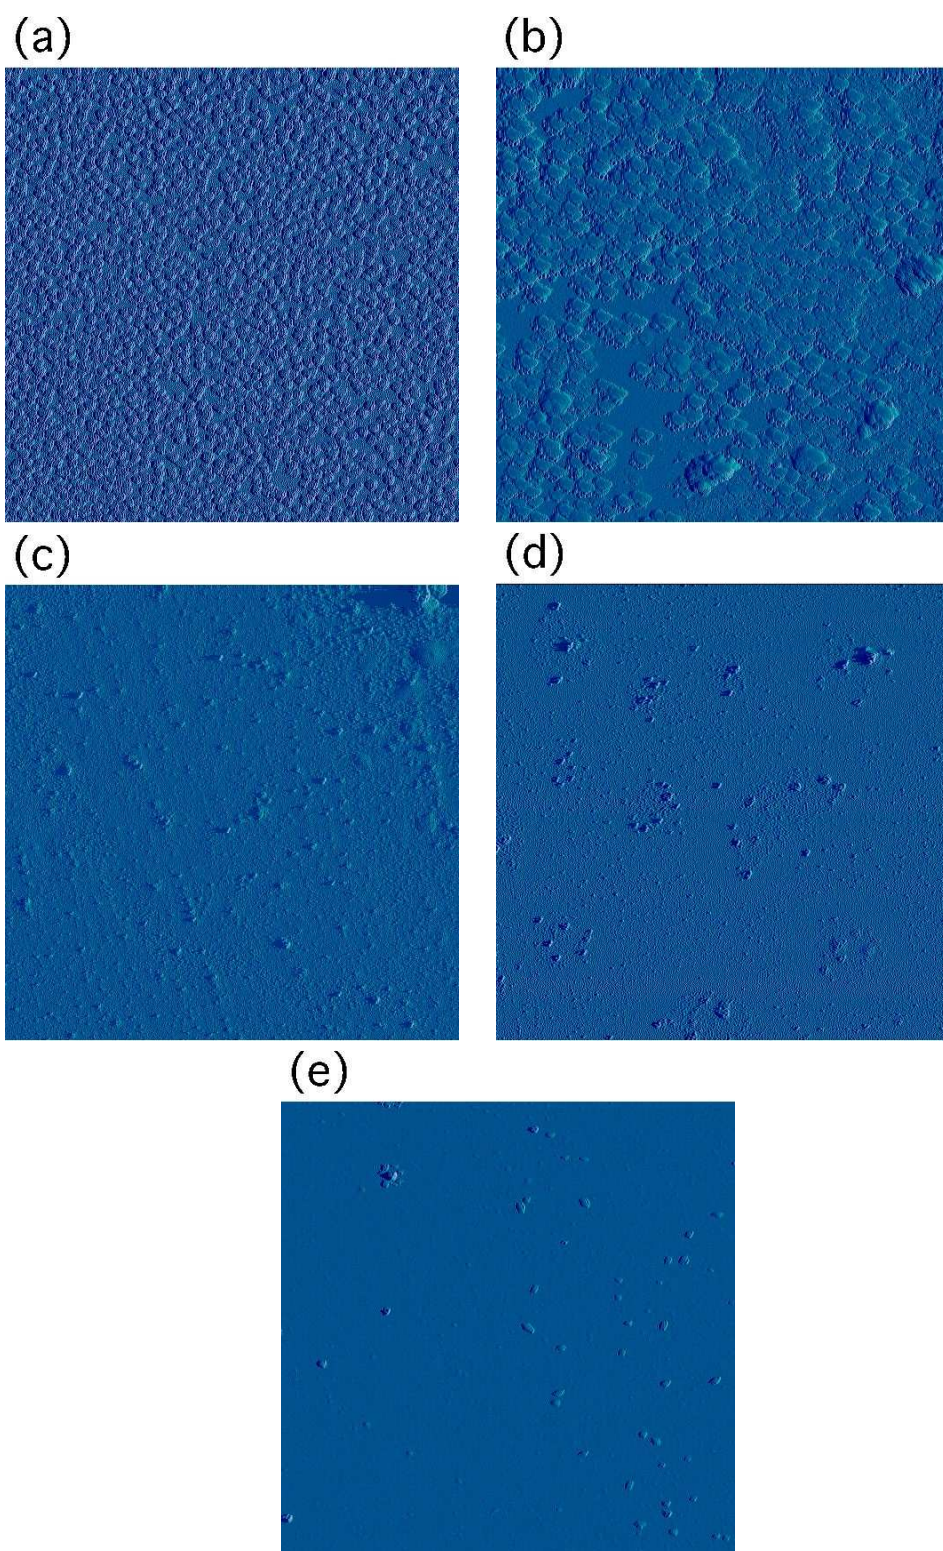
The AFM pictures of the glass surfaces are shown in Fig. 1. In the freon operated chamber, substances of  $0.05 \mu\text{m}$  in diameter and 100 nm thickness are seen on the anode. On the cathode, larger diameter ( $0.08 \mu\text{m}$ ) and irregular shaped substances are seen. We consider the substances as deposits on the glass based on these pictures. This explanation is also supported by the fact that the damaged electrodes can be recovered by scrubbing them using paper dipped in alcohol (2). In the freonless chamber, the observed substances are much smaller ( $0.005 \mu\text{m}$ ), both on the anode and cathode.

In conclusion, the AFM picture clarified the scenario of GRPC damage; when glass RPCs are operated in the streamer mode in a chamber gas containing freon and operated under water vapor-contaminated conditions, deposits are formed on both the anode and the cathode surfaces. These substances reduce the work-function of the electrode surfaces, leading to the field emission of electrons from the cathode. This reduces the electric field inside the chamber below the efficiency plateau and causes a permanent efficiency drop.

Figure 1: AFM pictures of glass surfaces. (a) anode (freon), (b) cathode (freon), (c) anode (freonless), (d) cathode (freonless), (e) brand new glass. The size of each frame is  $10 \times 10 \mu\text{m}$ .
